This errata sheet provides updated information about known device issues affecting Arria® II GX devices.

Table 1 lists the specific issues and which Arria II GX devices are affected.

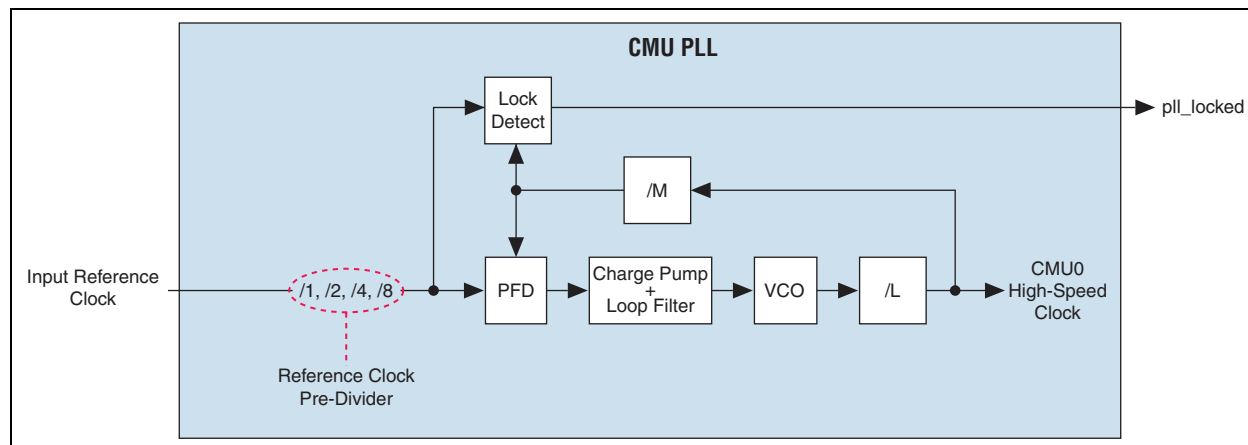
**Figure 1. Reference Clock Pre-Dividers in Transmitter PLLs**

The transmitter phase-locked loop (PLL) lock status signal (pll\_locked) does not de-assert when the pll\_powerdown signal is asserted in configurations that use the reference clock pre-divider of 2, 4, or 8. [Figure 1](#) shows the reference clock pre-divider inside transmitter PLLs. This issue impacts the pll\_locked status signal in the clock multiplier unit (CMU) PLL.

If the pll\_locked issue impacts your design, instantiate and connect the pll\_locked\_soft\_logic module, as shown in **Figure 3**. You must use the pll\_locked\_to\_corelogic output from this module in the transceiver reset logic and any user logic that relies on the transmitter PLL lock status signal.

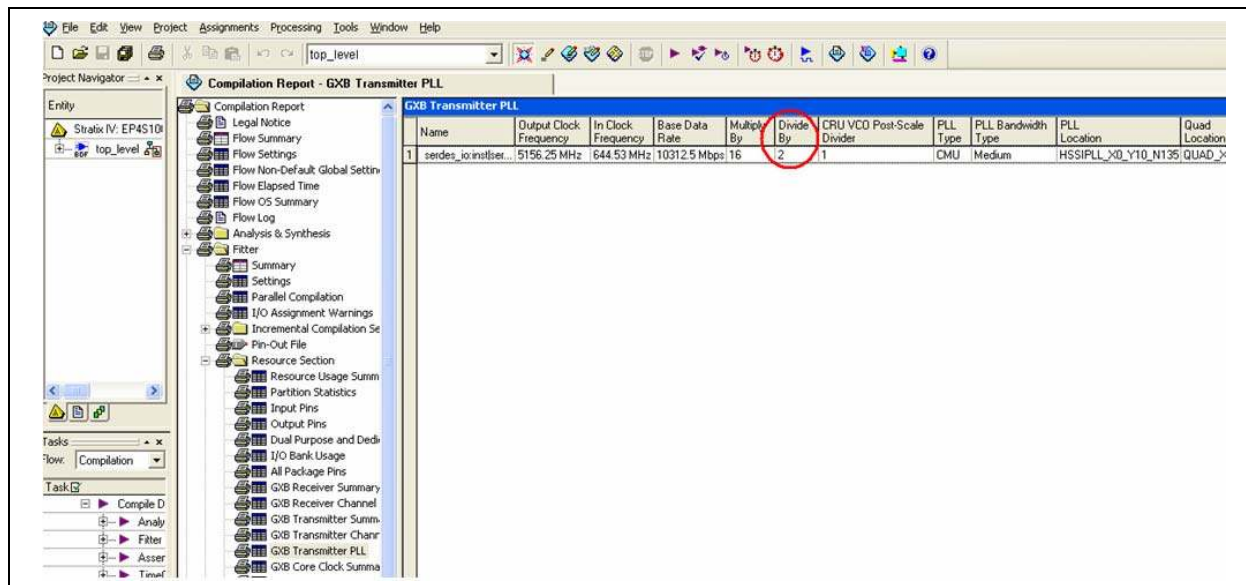
**Figure 2. Determining Reference Clock Pre-Divider Value in the Compilation Report**

You can determine if the Transmitter PLL in your design uses a reference clock pre-divider of 2, 4, or 8 by referring to the Quartus II software Compilation Report. **Figure 2** shows an example of the “GXB Transmitter PLL” report, which you find in the “Resources Section” under “Fitter” in the Compilation Report. If the value in the “Divide By” column reads 2, 4, or 8, your design is impacted by the pll\_locked status signal issue.
